TAMPERPROOF DULUX PAINT CONTAINERS

Synopsis

This case illustrates a product redesign to increase resistance to crime in the form of counterfeiting. The case analyses the redesign and manufacture of a plastic paint container lid. ICI began experiencing counterfeiting problems with products sold through a DIY chain operation in the Birmingham area. Containers were discovered which had been opened, the contents decanted off and replaced by coloured water. Technical and Development Manager Glyn Staines of RPC Containers Ltd was asked by ICI paints to redesign their paint containers to evidence any tampering. Staines and his team solved the problem by redesigning the lids such that the open screwdriver slots, designed to enable the container to be opened easily, were covered by a very thin plastic membrane. This maintained the easy opening facility but it was evident at a glance if the lid had been tampered with. The solution was also designed with manufacture in mind. Minimal changes were needed to the tooling, ensuring a very cheap solution to a potentially very damaging problem for the client. The redesigned product was in full production within two months of RPC being alerted to t

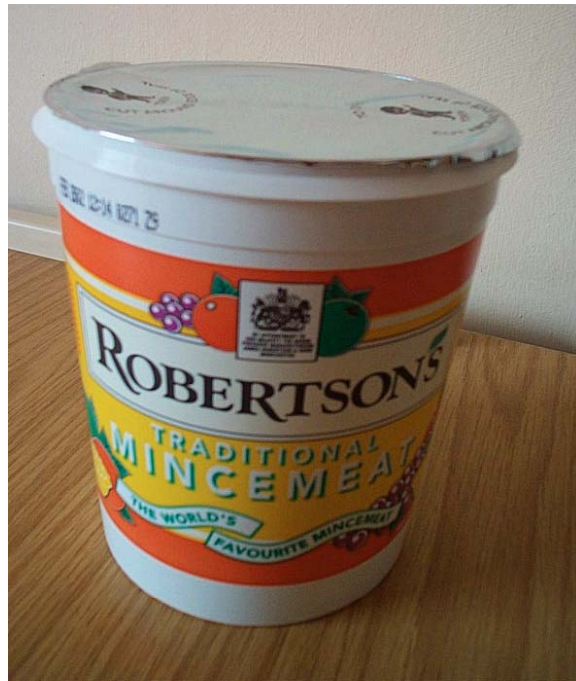
Figure 1: Photo of sealed membrane and tear-off strip solution for food packaging

The Oakham factory has been producing injection moulded plastic containers for 27 years and is a major supplier of these products to such household names as ICI, Nestle and Unilever. The major type of crime considered a problem by the packaging industry is that of tampering with the products contained in the packaging. This is a big issue for the food industry, with several well-publicised cases bringing the problem to the attention of both the packaging industry and the public. Thus tamper-evident packaging has become the norm for many foods from soups to coffee to margarine. RPC's major food customers therefore have required RPC to come up with tamper-evident packaging for many years. Sealed membranes and tear-off strips, as shown in Figure 1, are the most common solutions.

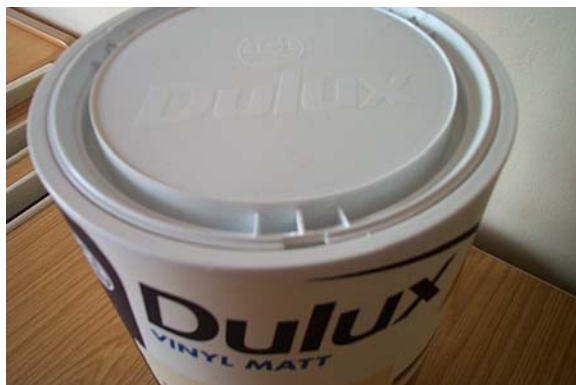
Figure 2: Photo of old design of Dulux lid and container

After the initial meeting with ICI, Staines and his six strong development team brainstormed the problem. A member of the team suggested that if the open screwdriver slot, which allows easy entry into the container, (see Figure 2) were covered with a very thin plastic membrane, then it would be evident if someone had tried to open the tin just by looking at the lid.

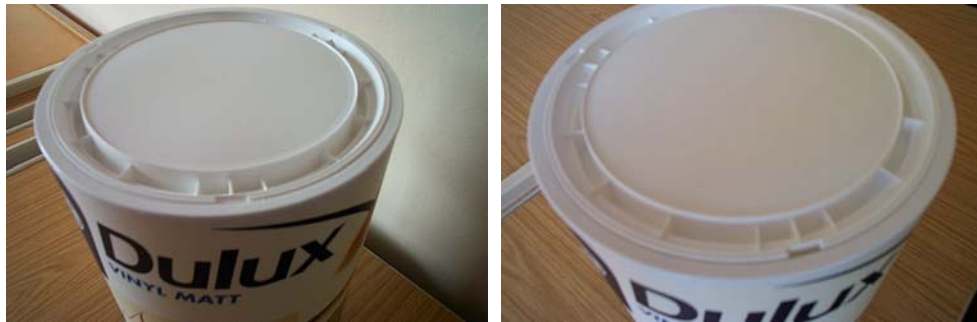
Figure 3 (left) Redesigned lid showing new 'closed' slot design, before opening and Figure 4 (right) Redesigned lid after opening showing evidence of tampering

moulds had the potential to be expensive. However, the RPC team's understanding and experience of the process ensured a cost-effective solution. The thin membrane required to provide evidence of tampering required a little extra plastic to be moulded into the lid. This meant therefore that only a minor modification was required to the mould. A small amount of metal needed to be shaved off the lid-mould, to allow the extra plastic to flow in. A cheap, easy, ingenious solution to what could have been a very costly image-damaging episode for ICI. Figure 3 shows the redesigned lid before opening. Figure 4 shows the lid replaced after opening. Evidence of opening can be clearly seen.

If the counterfeiter attempts to open the lid anywhere else around the rim in an attempt to circumvent the new membrane, then the rim is damaged and again this is obvious to the eye. The whole redesign process from the raising of the problem to the redesigned containers being in full production took only two months.
