## BARREL ROOFED BUS SHELTERS

### Synopsis

This case illustrates a product designed to increase resistance to crime in the form of violence against the person. The case analyses the design, development and manufacture of a new bus shelter for South Yorkshire Passenger Transport Executive. The new Operations Manager became responsible for bus shelters in South Yorkshire when SYPTE took over the responsibility for the bus infrastructure from the local councils some 10 years ago. He found the existing shelters totally unsatisfactory. Passengers felt unsafe and shelters were heavily vandalised. This case describes how he put his 'see and be seen' vision into practice by finding a supplier with whom he could work to design a shelter which increased the safety of the travelling public. After six months of intensive work the new design was tested and approved. 1500 of these new shelters have now been installed. As a result of the new design, an aesthetically pleasing, illuminated, glass panelled shelter, and better maintenance, passengers have reported feeling safer, residents have developed a sense of 'ownership' of their local shelters and vandalism has reduced.

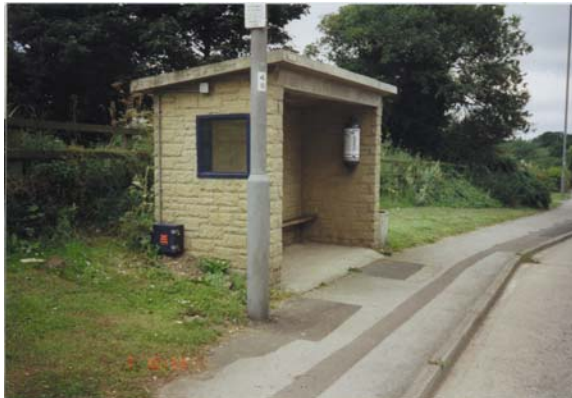
South Yorkshire Passenger Transport Executive took over the responsibility for bus shelters from the local authorities some 10 years ago. At this time, the bus shelters in South Yorkshire were, generally, in a very bad state. Shelters were of various designs. Some were brick or stone designed to blend in with the environment, such as that shown in Figure 1.

*Figure 1: Stone shelter designed to blend in with the environment*

“People tended to wait outside the shelter. They couldn’t see the bus from inside the shelter. They didn’t feel very safe. They didn’t know who was lurking the other side of the wall and these shelters tended to get used as public lavatories.”

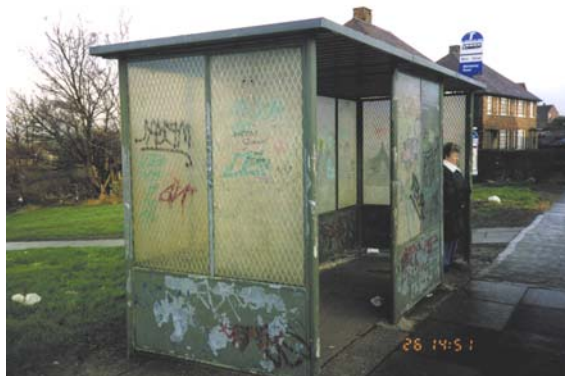
Not all shelters were of this design, the most common had a painted metal lower half and a wire-strengthened glass upper half. But there was no illumination in these shelters; people felt little safer than in the brick and stone structures. Shelters were regularly vandalised, the glass smashed, the panels covered with graffiti. The councils had no maintenance budget for the shelters and they became eyesores. A typical shelter from this time is shown in Figure 2.

*Figure 2: A typical pre-SYPTE bus shelter*

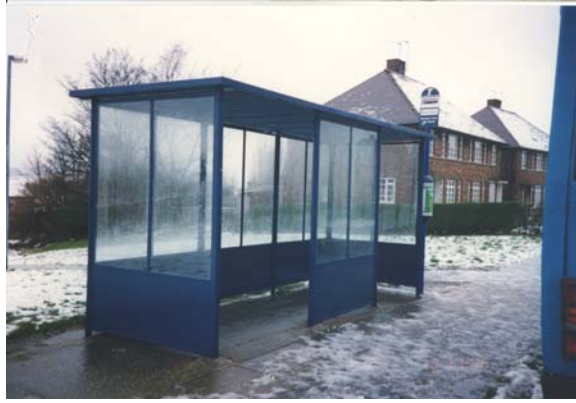
The dramatic design modifications made can be seen by comparing the original Abacus design, shown in Figure 3, with the design developed in partnership with SYPTTE, shown in Figure 4.

*Figure 3: Original Abacus bus shelter design*

Continuing the 'see and be seen' requirement, illumination was seen as a necessary element by both supplier and purchaser. This could be achieved in the original design by suspending lighting holders from the flat roof. The Operations Manager was not satisfied with this; it gave an inadequate level of light because of the opaque nature of the roof and could be easily vandalised. It was he, the purchaser, not the designer, who came up with a radical design idea, a translucent barrel roof to solve these problems. Abacus worked on this idea and Figure 4 shows the new design, incorporating the barrel roof, in which the roof is made of translucent polycarbonate and the illumination strips are incorporated into the roof just above the roof base frame. The new roof design also provided a neat solution to the problem of where to put the bus stop location information. Previously this required a display 'flag' or board which was perched on the end of the roof (see Figure 3).

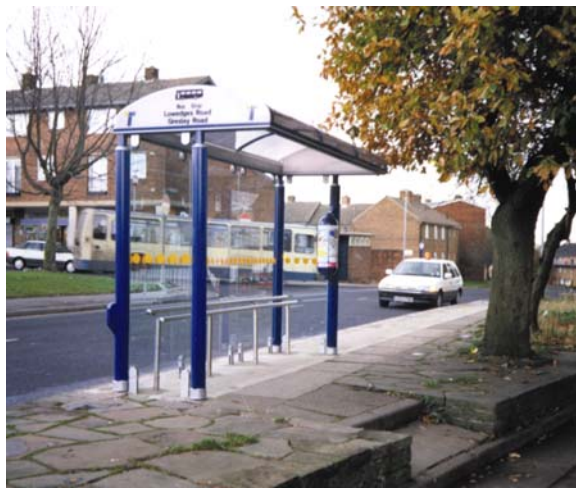
*Figure 4: New barrel roof design*

The new floor to roof glazing gives a clear view from inside the shelter outwards and vice versa – a need expressed by SYPTE and satisfied by Abacus.

The 'perch' seating is also a design addition. Passengers wish to wait for a bus in some degree of comfort, however, if full seats are installed, this can cause problems with anti-social behaviour. As Bowen explains:

"when the first one went in, everyone from SYPTTE was there from the Board down. We had no bad feedback from anyone, our staff or the passengers. The only modification we needed to make was to add a 'bubble' on the leg to house the electricity fuse. Our design incorporated the fuse into the leg, making a very neat line, but Yorkshire Electricity were unwilling to connect up their supply using this type of fuse, so a 'bubble' had to be added to take the larger fuse, specified by them."
